Lawrence Livermore National Laboratory
Experimental Test Site 300

Compliance Monitoring Program for the
Closed Building 829 Facility

Annual Report
2006

LLNL Site 300 Building 829 Landfill Cap Annual Engineering Inspection

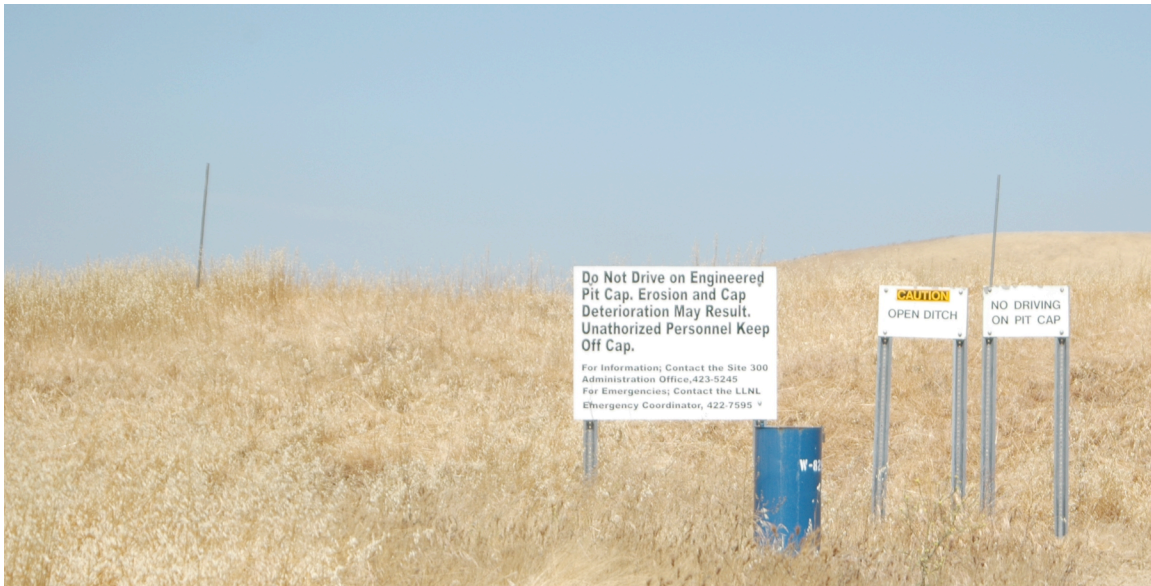
Figure 3 **Building 829 Landfill**

Building 829 Landfill cap is generally in good condition; the vegetation cover is relatively thick and covers the soil cap over the pits; there is no visible erosion of the cap; and the drainage system is in good condition and appears to be functioning as intended. The groundwater monitoring system appears to be in good condition as well. Some evidence of animal burrowing was observed. Recommendations on these observations are made below.

The landfill had a 3 ft high retaining wall at the southwest corner of the cap. The wall appears to be in good condition and appears to be performing as intended.

There are few small burrowing animal holes, approximately 2 inches in diameter, on the cap. A few larger burrowing animal holes, approximately 8 inches, were observed primarily on the north side near the V ditch. It is recommended that holes exceeding 18 in. in depth and 6 in. in diameter be repaired.

- Fill in the animal holes exceeding 18 in. in depth and 6 in. in diameter on the cap and reseed where necessary

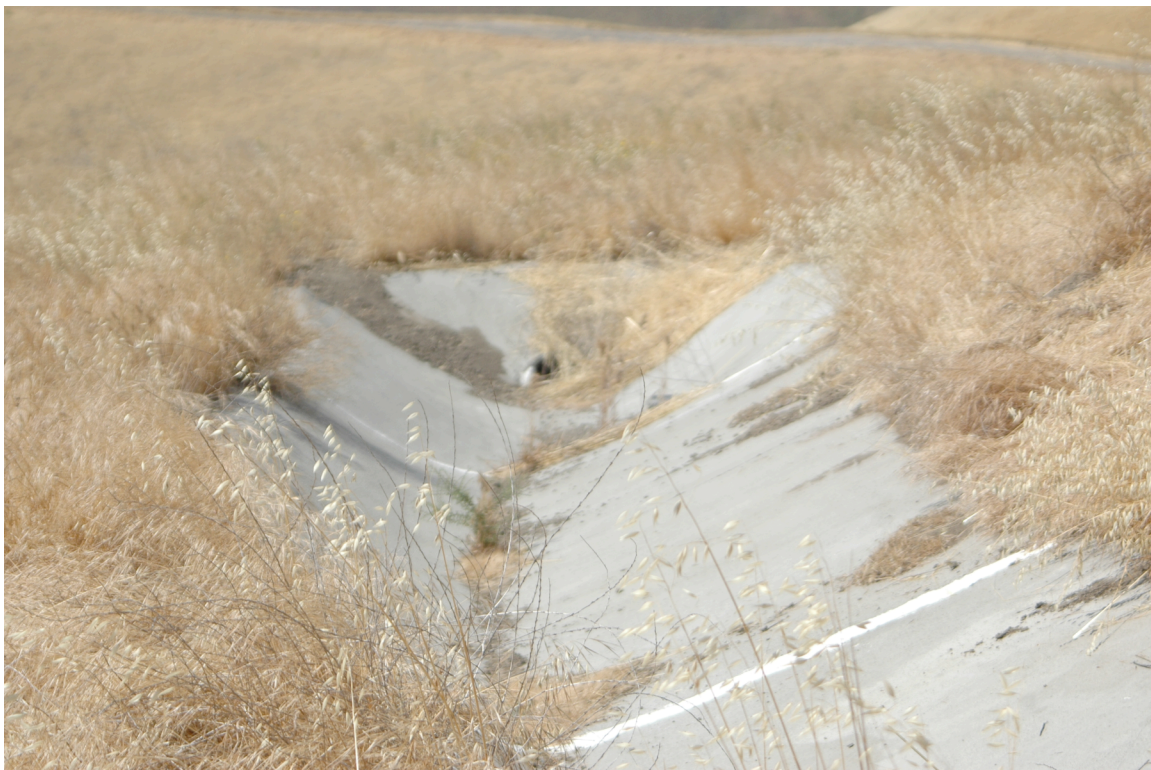
Figure 4 **Building 829 Landfill Drainage Ditch**

Surface runoff diversion structures consist of a perimeter drainage V-ditch. The V-ditch has expansion joints every 12 ft and every other one is caulked. The remaining expansion joints appear to be saw cuts partially onto the surface of the concrete. The structure also collects water from the "drainage layer" of the cap through a series of drainage pipes. Concrete lining appears to be in good condition. The ditch end at northeast corner is low and minor amounts of ponded water and vegetation is present, see Figure 4.
